## About RToucan, Hybrid Jett60, pushrods and soldered connections

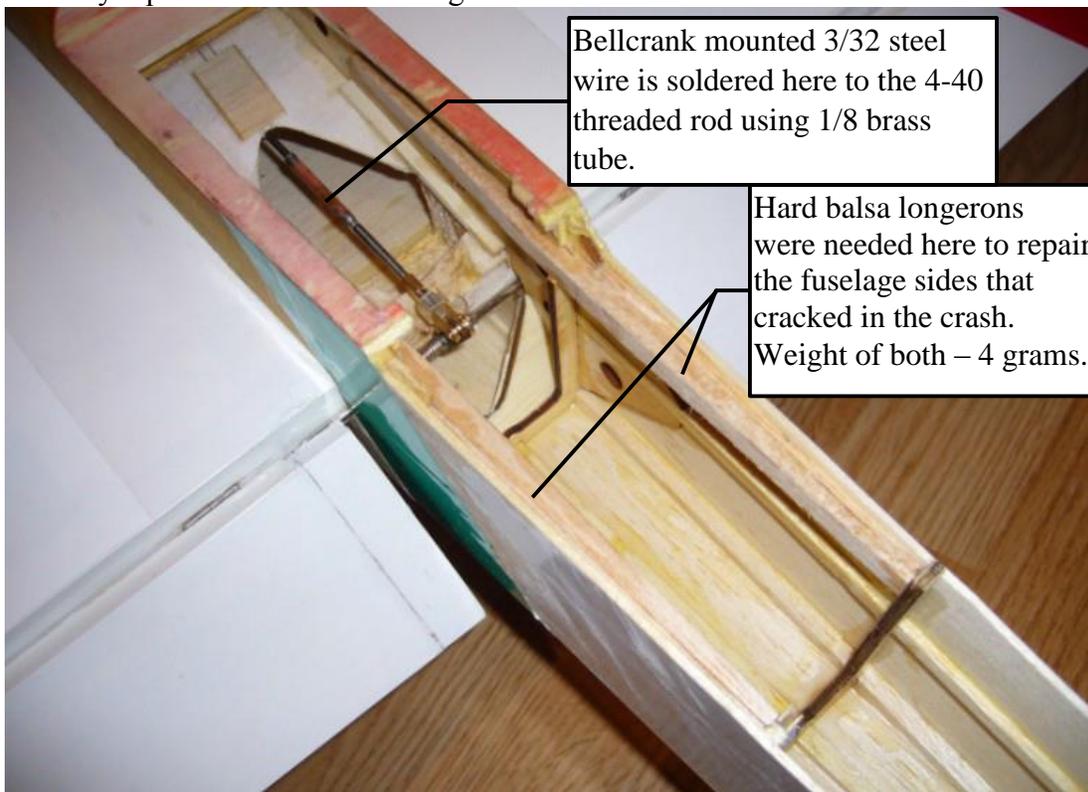
Ad.2 Partially repaired RToucan's fuselage is shown below.

The soldered connection visible above was rebuilt and uses now the coarse 4-40 threaded rod instead of 2-56 fine thread rod. Original Score ARF 2-56 spring clip has been replaced by Sullivan “gold” steel 4-40 threaded spring clip.

This soldered connection has been tested using a separately built test piece that survived 55 lbf. static tensile load.

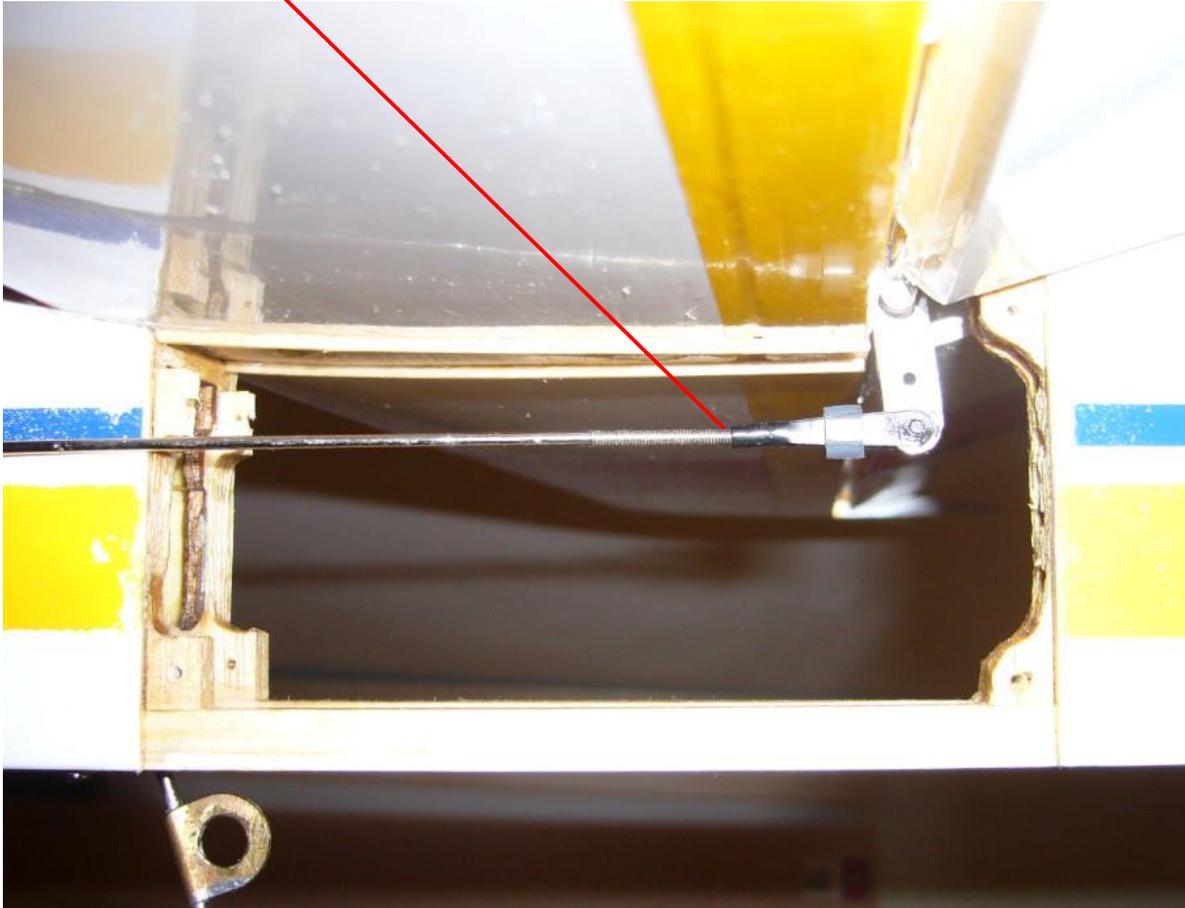
I suspect the 2-56 threaded rod with original Score ARF spring clip connected to the elevator horn failed in flight and this was the root cause of the crash.

I have found this 2-56 thread disconnected and partially damaged after the crash and the threaded connection is now very loose.

This connection will be replaced by 4-40 coarse threaded rod and the Sullivan clip.

The carbon composite tube of the pushrod (not shown) has the hard wood plugs on both ends and both 4-40 threaded rods will be epoxied in these plugs.
